Toronto, Ontario Canada
March 29 – April 3, 2009

Paper C-1-01

Auger Boring Challenges in the Virgin Islands

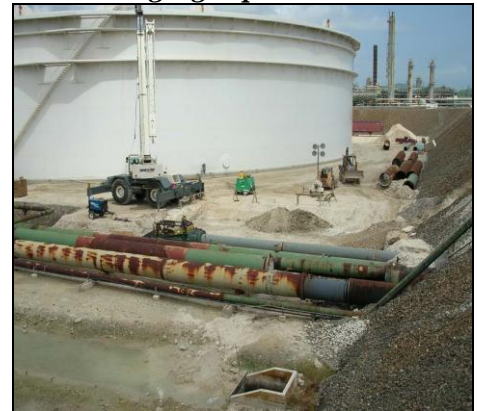
Aging Pipelines

The original pipelines, constructed at such an angle that made renewal impossible, now intersected major fire and power lines. Trenchless auger boring was chosen as the most suitable replacement method and construction began in early October, 2007.

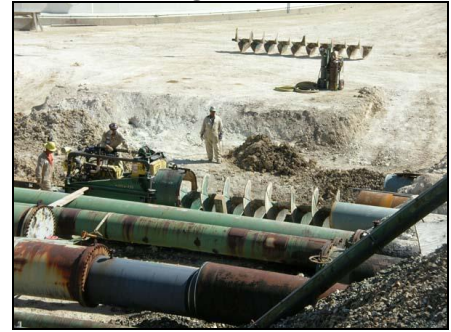
Auger Bore

The project called for four auger bores to install (2) 30" OD steel casings and (2) 48" OD steel casings. Along the 120' bore path, each of the steel casings had to pass through at least six different soil types ranging from coral cobbles to sticky clay. This proved extremely challenging because of the lack of binding material in the outer layer of coral that could have resulted in cave-ins, and the density of the inner layer of sticky clay that made turning the auger impractical.

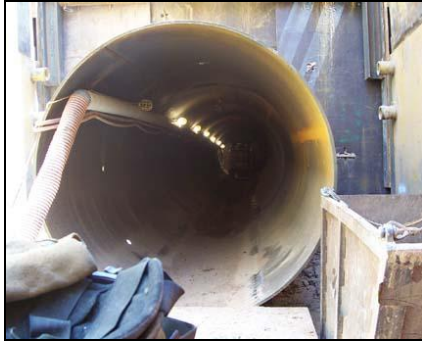
Methods Considered	Advantages	Disadvantages
HDD	None	None
Hand Tunnel	Line and Grade Accuracy	Not allowed due to Safety Rules
Auger	Speed	Drift of casing
Pipe Ramming	No voids	2 steps to install, vibration, noise

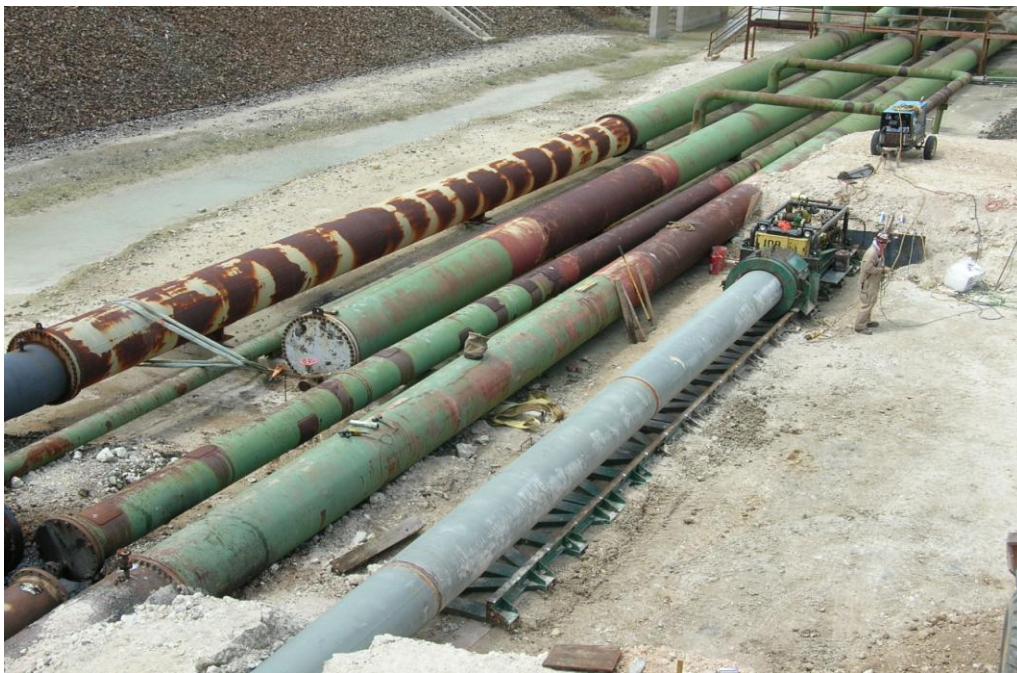
To minimize the cost and risks associated with this project, horizontal auger bore was selected as the most suitable method. Four 120' auger bores to install (2) 30" OD steel casings and (2) 48" OD steel casings were required.

4- 120' bores planned to replace existing casing

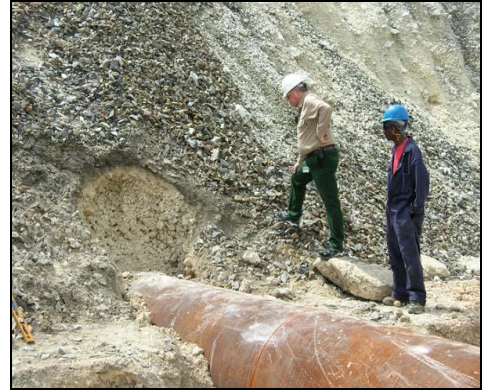
Loose Coral

Installation Challenges: Construction began in early October, 2007. The first of the two bores to install 48" OD steel casing failed. Extreme weather had stripped the binding material from the outer layer of coral causing the loose material to cave in. Dropping a foot below grade, a second bore successfully cleared the loose material but became bound in dense sticky clay at approximately 60ft. Water was pumped in and around the auger to loosen the clay and allow the auger to glide for another 40 ft. Once again the auger encountered the outer layer of coral as it exited the dike making turning the auger impractical. It was then shut down and used as a jacking device for the remaining 20 ft. successfully avoiding an overflow oil drain that was discovered during the installation

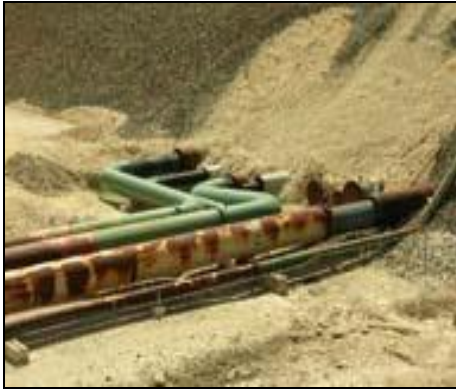
New Fuel Lines Side A

With little room to maneuver, and little time to spare, each of the three remaining casings were installed successfully and the project was completed in mid October 2007, amazingly eight days ahead of schedule.
