**North American Society for Trenchless Technology (NASTT)  
NASTT's 2014 No-Dig Show**

**Paper WM-T5-04**

**Pushing Horizontal Auger Boring to the Limit**

Arvid Veidmark III, Specialized Services Company, Phoenix, AZ  
Abe Veidmark, Specialized Services Company, Phoenix, AZ

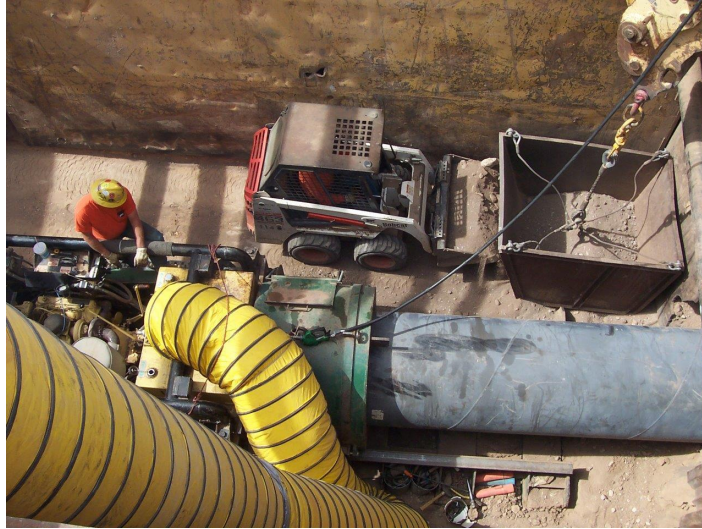
Figure 3: Bore Pit for Auger Bore Installation of 42” (106.7 cm) Steel Casing, with blower hooked up to help with cooling the machine.

As had been anticipated when evaluating method options, equipment capacity was challenged with a crossing of this size and length. Issues were encountered with the bit, auger and bore machine during the course of the project. Figure 3 provides an overview of the bore pit set up and equipment utilized to perform the work.

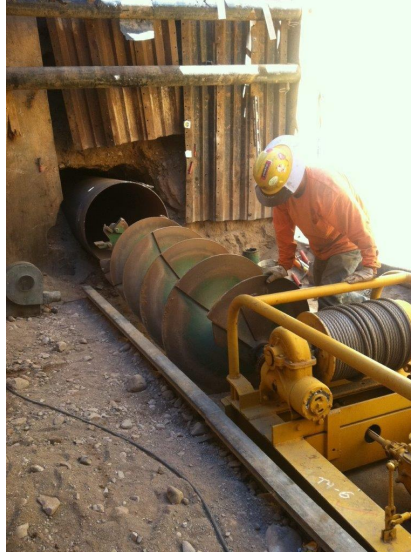
Figure 4: Hydraulic tugger being used to pull broken auger out of casing.

Now at the 517’ (157.6 m) mark for casing installed, the shear force exerted on the auger when that quantity is being turned resulted in the shaft snapping. This was the first occurrence of this problem which occurred again on February 19 at 530’ (161.5 m) and February 26 at 580’ (176.8 m). Each time the auger broke it created at least a two day delay for all of the auger to be removed, the broken piece to be removed – in some cases requiring it to be cut off inside the casing and in one case the flighting had to be cut inside the casing to allow the crew to reach the point of the break and free the broken auger. To expedite the process after the 580’ (176.8 m) break, a hydraulic tugger (shown in Figure 4) was brought in to use to pull out the auger instead of the bore machine.

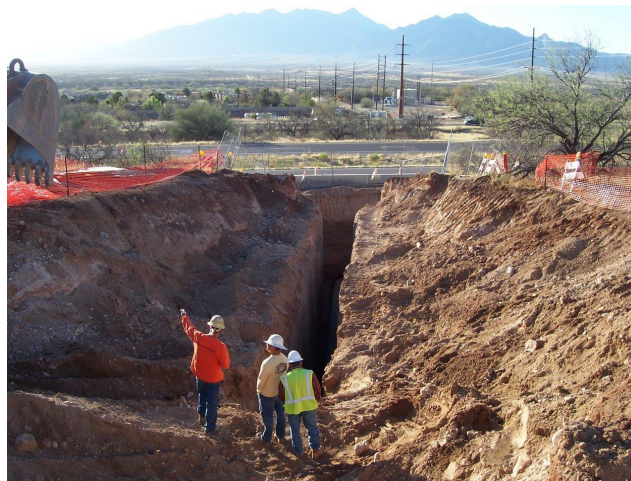
Figure 5: Reception side of crossing, showing 80' (24.5 m) of open cut.

The 80' (24.5 m) of open cut trench was dug on April 3 along with the reception pit. Figure 5 shows this completed section of open cut. While this was happening on the reception end of the bore, the auger was pulled from the casing on the bore side. On April 4 and 5 the remaining 80' (24.5 m) of casing was welded to the bored casing and pushed from the bore side into the open trench until the full length had been installed and reached the reception pit. At this point the open cut trench was backfilled with slurry per ADOT specification, resulting in only 3 days of traffic restriction within the ADOT right of way.

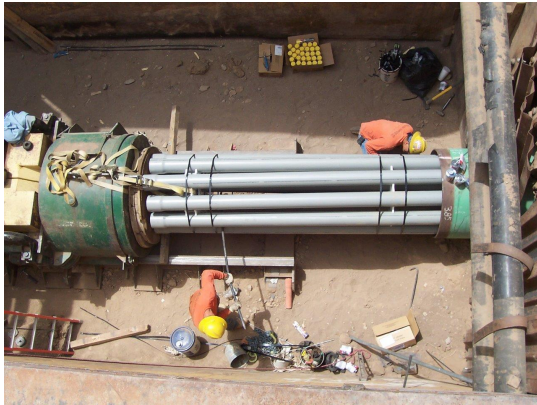
Figure 6: Conduit bundles being pushed into 42" (106.7 cm) casing

For the next two weeks, guide rails were welded inside the casing, and the PVC bundles of 14 – 6" (15.2 cm) Schedule 80 conduits were built and pushed – these are illustrated in Figures 6 and 7. Once all the conduit bundles were installed and bulkheads were built, the final step was to grout the annular space inside the casing.

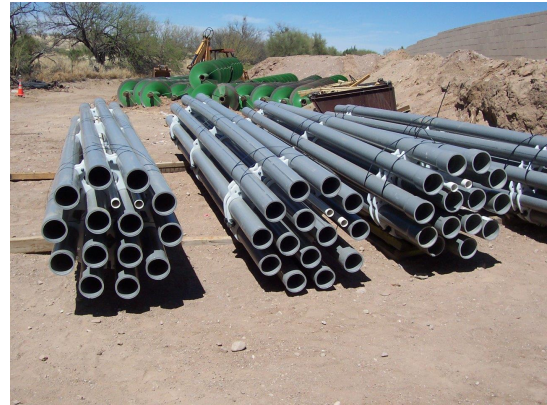
Figure 7: Conduit bundles of 14 – 6" (15.2 cm) Sch 80 PVC

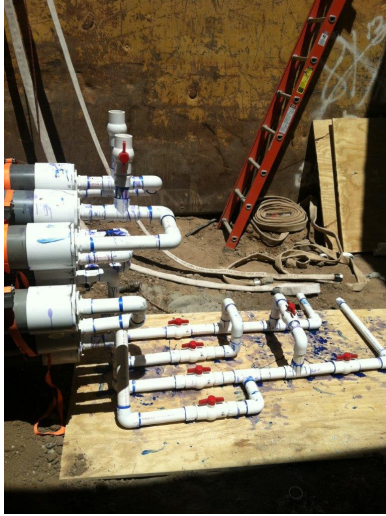
Figure 8: Plumbing on bore side

The PVC conduits were utilized as part of the solution. As shown in Figures 8 and 9, a plumbing system consisting of couplers and connections to connect the individual PVC conduits and create a continuous pipeline through which cool water could be pumped to help dissipate the heat was constructed. Water was hauled in by water truck and pumped through the conduits and a 2000 gallon (7570.8 liter) water truck tank and then drained into a tub, shown in Figure 10, and subsequently pumped from the pit. This cooling operation continued for 24 hours after grouting was completed, and even the next day the water temperature was being raised over 30 degrees to 107 degrees Fahrenheit (41.7 degrees Celsius) by the heat generated from the grout.

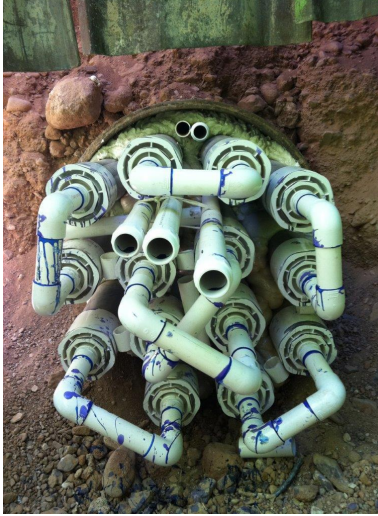
Figure 9: Plumbing on reception side  
3 grout lines open in center
